# Public summary of the list of material properties and selection guide for Los Humeros North

**Deliverable 8.5**

Responsible author: Ingólfur Þorbjörnsson (ÍSOR)

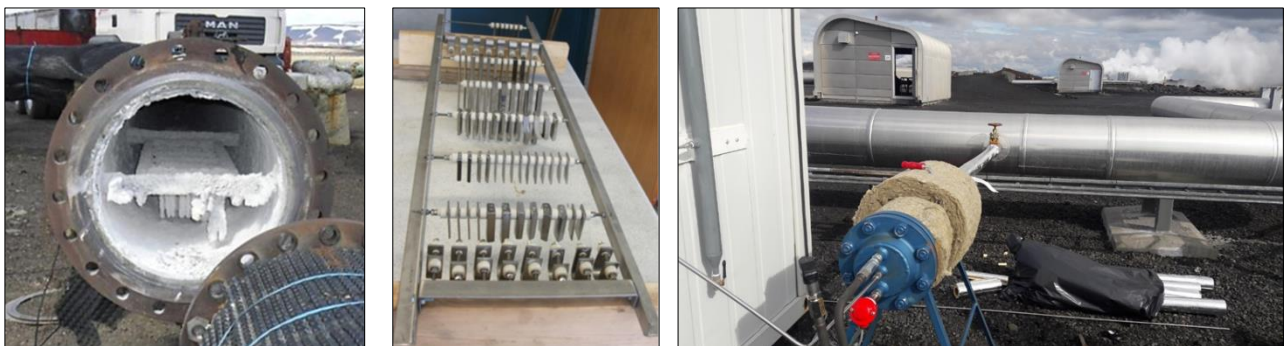
**Figure 1.** Surface testing. On the left steam pipe to the silencer with sample rack as shown in the middle picture. On the right corrosion tank with steam inlet from the main steam pipe.

For testing materials for corrosion resistance in a geothermal well there are several options. First is the surface test that can be carried out in the steam pipe, either the main pipe to the power plant or the one leading to the silencer. Another option for surface testing is to pipe steam from the main steam pipe into test tank and even into an autoclave system. The types of surface testing previously used in Iceland are shown in Figure 1.

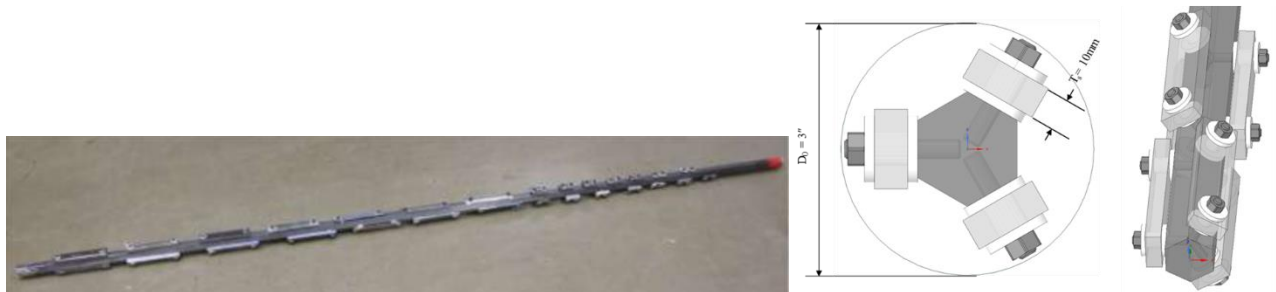
**Figure 2.** *Sample rack for downhole testing. Hexagonal bar with attached samples on the left ready for downhole testing in well in Iceland (Karlsdottir and Thorbjornsson 2013). On the right drawing showing how ceramic washers are used to ensure no metal to metal contact between sample and test bar.*

Another option for testing is downhole testing. Downhole testing is primary selected to enable testing of casing candidate materials in real conditions downhole in the well, preferable in blending zone between fluid from two fractures or in conditions with liquid from one selected fracture. Downhole testing is though more demanding than surface testing as the testing material is lowered into the well by wire line and the risk of material loss is severe. Downhole testing also puts limitation on size and volume of the testing material. Samples need to be fully insulated from the sample holder and bolts, this is shown in Figure 2.

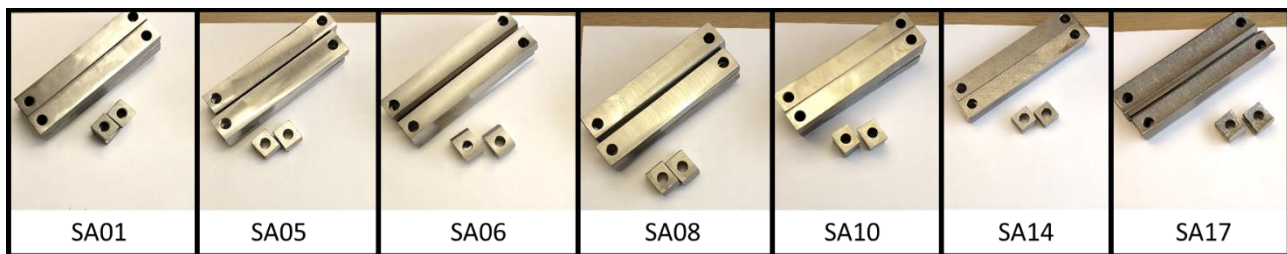
**Figure 5.** Figure showing the samples used in Los Humeros. Three larger specimens and two smaller of each material was used for downhole testing.

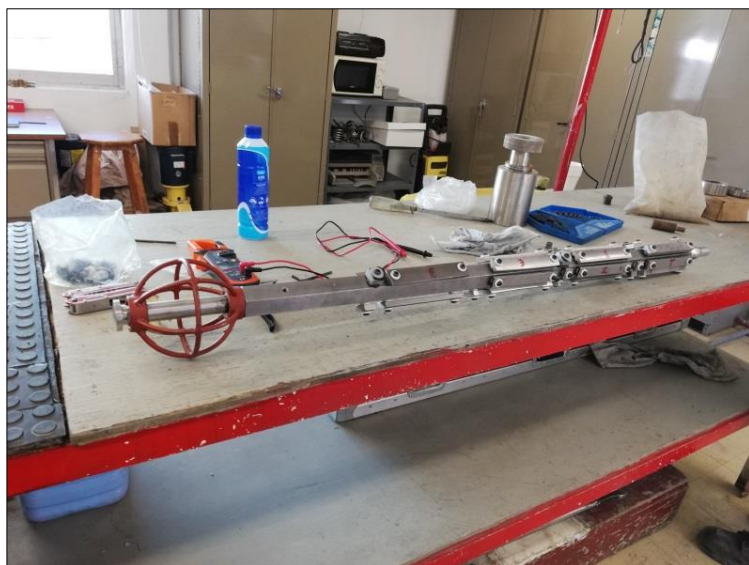
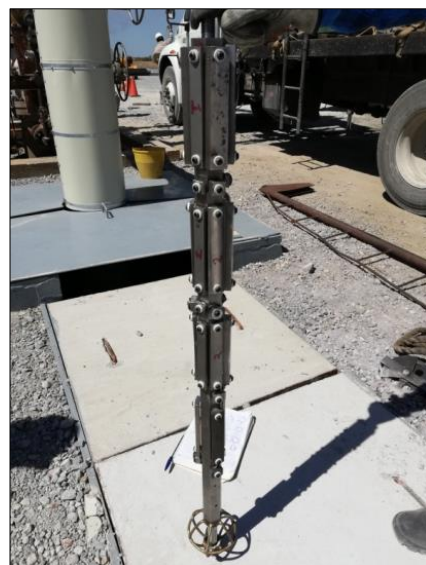
**Figure 6.** *Hexagonal test bar with test samples. Pictures from CFE.*

Downhole testing in well H-64 started on the 21<sup>st</sup> of February. The hexagonal bar with 35 samples from 7 materials shown in Table 3, were lowered down to 1290 m depth. The original plan was to go deeper, to 1350 m but due to some obstacles in the well it was not possible to reach that depth. As can be seen in Figure 3 the production casing end in 1300 m and therefore the test bar was close to the end of the production casing, at the top of the perforated liner. The hexagonal test bar, 1.03 m in length and 79.4 mm in diameter with samples, was made from carbon steel. Slickline wire used was Hastelloy C-276 with 0.092" or 2.3 mm diameter. Before lowering the test bar with samples, all samples were measured to make sure that no electrical conductivity was between samples and the hexagonal bar. At the end of the hexagonal bar a balloon like centralizer was attached. The setup before testing is shown in Figure 6. In Figure 7 lubricator for lowering the samples downhole as well as the hexagonal bar with centralizer and samples can be seen.

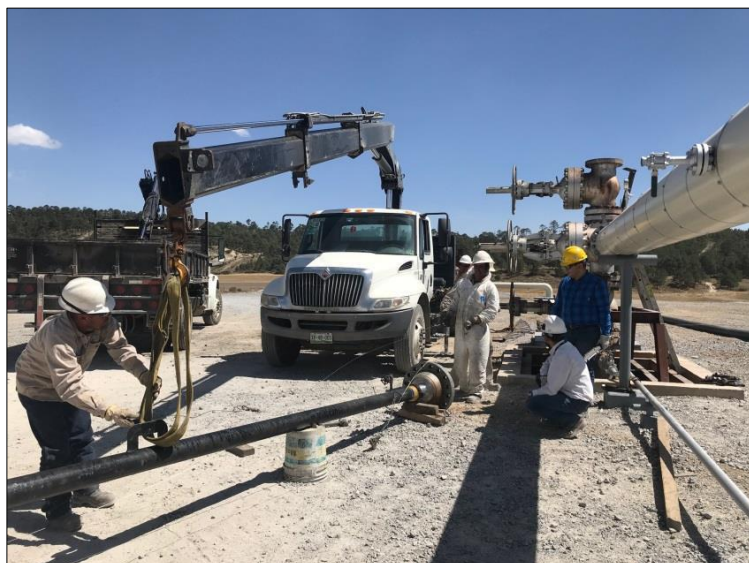
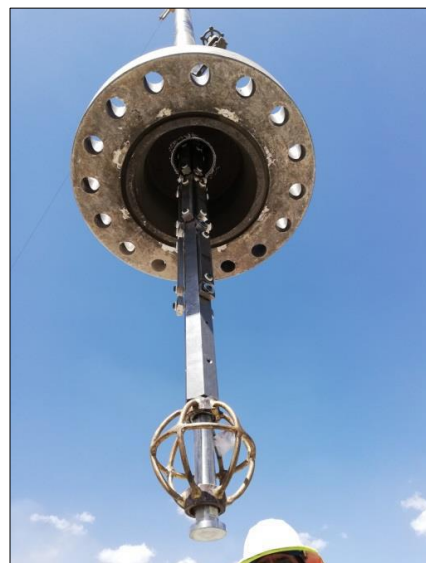
**Figure 7.** *Preparations at well head for lowering the hexagonal sample holder with samples downhole. Pictures from CFE.*

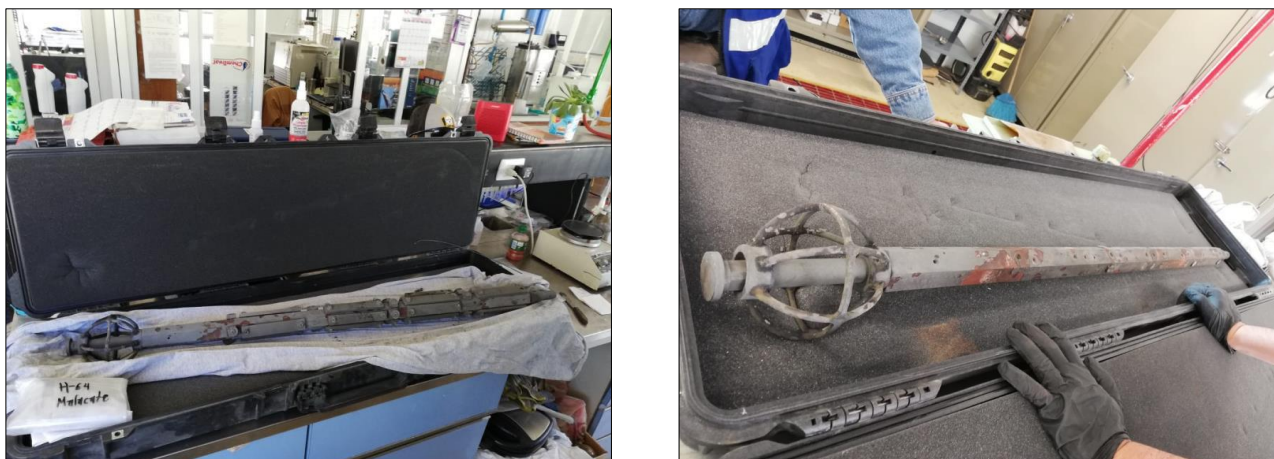
**Figure 8.** *Pictures showing the hexagonal bar as retrieved.*

Testing started on the 21<sup>st</sup> of February 2019, time was 14:34 when the bar was lowered into the well and at 15:30 it had reached the testing depth of 1290 m. The test bar was then retrieved from the well with all specimens safely to the surface on the 7<sup>th</sup> of March at time 9:42. At surface the test bar was securely transported to CFE facilities and inspected visually. As shown in Figure 8 the hexagonal test bar, centralizer and samples are covered by grey coloured scaling after two weeks in the well.

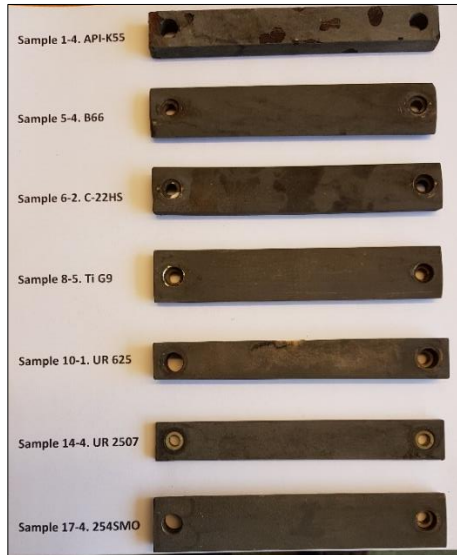
**Figure 9.** Samples as received from testing. Samples for XRD analyses were taken from scaling on sample 1-4, 5-4, 14-4 and 17-4.

Samples of materials, approximately 20 mm by 10 mm and 150 mm long, tested in a geothermal well in Mexico for a period of two weeks were analysed (Figure 9). Of all the samples used in the experiment, a few had notable surface deposits. The secondary deposits were removed from the samples using a stainless steel surgical scalpel and the material collected was ground and deposited onto a quartz (zero-background) sample holder using organic solvent (acetone). A Bruker AXS D8 Focus diffractometer was used (Bragg-Brentano goniometer), with Ni-filtered Cu  $\alpha$  radiation at 1.54 Å wavelength at 40 mA and 40 kV, with fixed 1° slits and NaI scintillation counter. Scanning range is from  $2\theta=4-64^\circ$ , with a step-size of 0.02° and measurement time of 1 second in each step. Interpretation of the results was done using a Diffrac.Suite EVA software from Bruker, associated with PDF-2 2019 database from ICDD.

**Sample 1-4 (upper surface):** Material API K55 was with visible severe scaling and corrosion as can be seen in Figure 9. Scaling revealed with microscopic inspection to be twofold, an upper layer and close to the steel a layer with notable difference from the upper layer. XRD analysis was conducted on both layers, here referred to as “upper surface” and “sub surface”. As seen in Figure 10, the material is iron-rich, manifested by the high background radiation caused by fluorescence of iron (red pattern) in the radiation wavelength produced by the Cu-anode. On the lower pattern the background radiation has been subtracted. Of the readily identifiable phases, pyrrhotite is abundant and magnetite is also notable. Boron-containing compounds match with considerable confidence. Sodium fluoride is also noted but due to the simple symmetry of such materials it is difficult to confirm its presence. Two large peaks were not found to match with any suggested and likely candidates and thus remain unresolved (at  $2\Theta=34.8^\circ$  and  $49.1^\circ$ ).

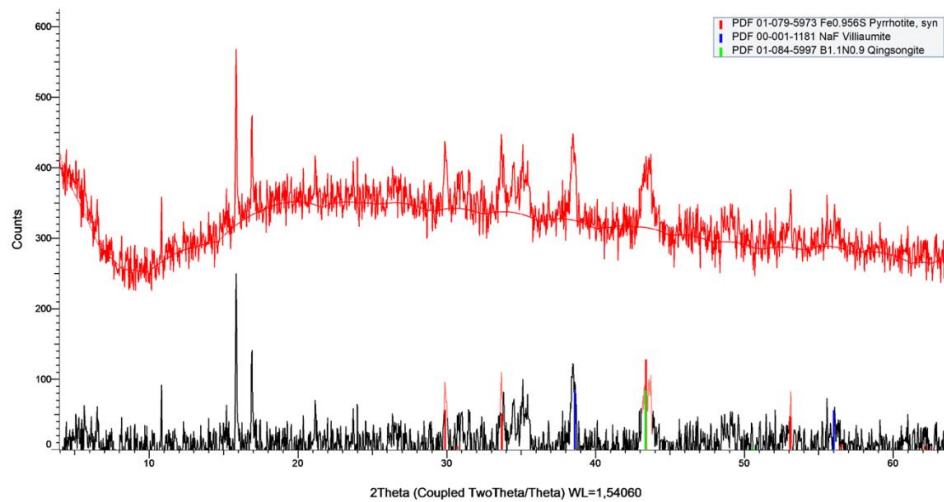
**Figure 11.** X-ray diffraction pattern of corrosion scaling on sample 1-4 (API K55) sub layer. The sample's pattern is shown both raw (red) and with background subtraction (lower pattern).

**Sample 1-4 (sub-surface):** The immediate surface below the surface deposit is mostly comprising pyrrhotite, but sodium fluoride and boron compounds could also be present (Figure 11).

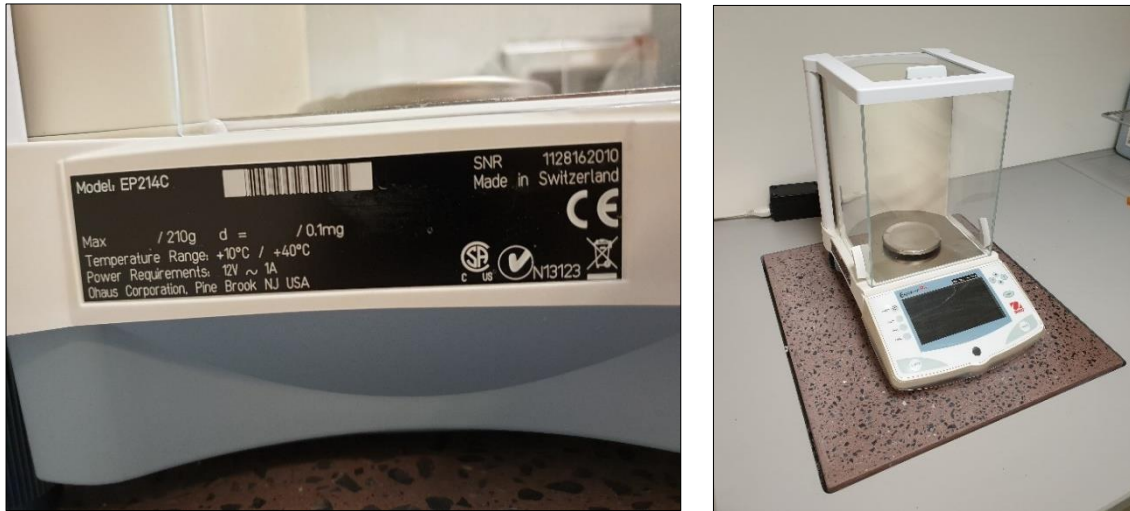
**Figure 15.** Precision scale, OHAUS Explorer Pro EP214C, used for weight loss measurement.

Samples were weighed on an OHAUS Explorer Pro EP214C as shown in Figure 15.
